# INSPECTION REPORT

PROJECT ELEVEN AUTO MECHANICAL  
SERVICES CO.

CUSTOMER	VEHICLE	INSPECTION
Nolemons.ae 971444	Porsche Cayman GT4 JAPANESE IMPORT NO PLATES WP0ZZZ99ZGK189317	23 08 Dec 2023 11:18 AM Total Estimate : 0.0 Approved : 0.0 To be approved : 0.0

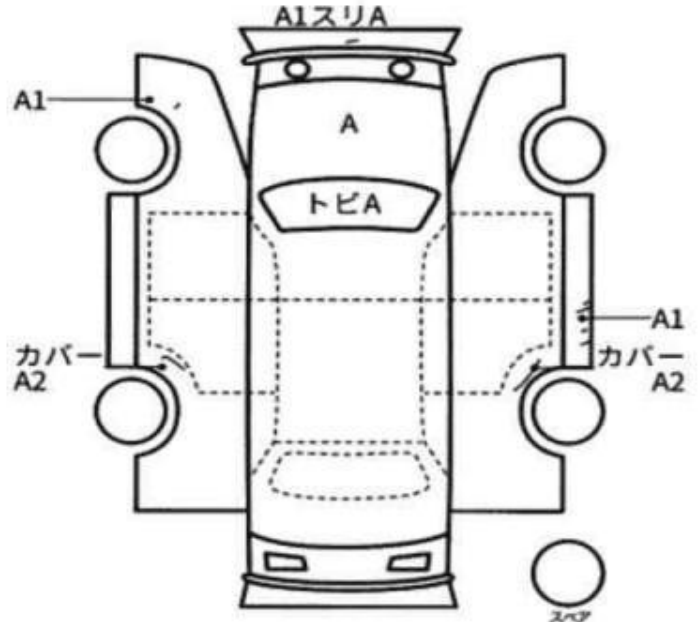
ナビ開閉一部不良  
ハーフレザーシートスレ  
小キズ, 小凹, ホイールキズ

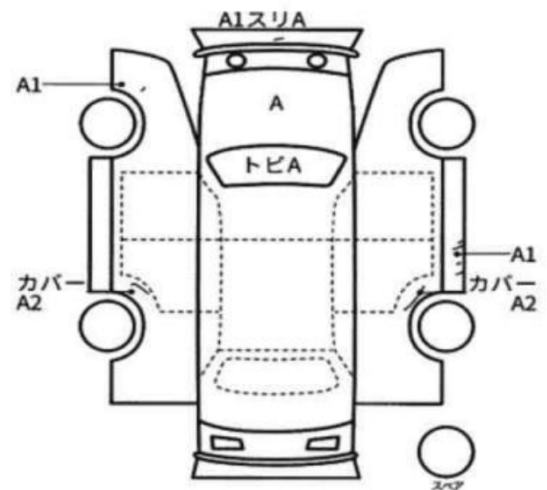
Slightly dirty cabin, scratches  
Navigation open/close part is defective  
Wheels small scratches  
Small scratches & dents on exterior  
Half leather seat scuffs  
Windshield small chips/scratches
